**REPORT OF PETROLEUM OR CHEMICAL PRODUCT  
DISCHARGE, SPILLAGE OR RELEASE**

Mobil-branded Retail Gasoline Station  
Interstate I-95 Southbound  
Madison, CT  
Facility #835

PROJECT: **Alliance Facility #834**  
 195 Southbound  
 Madison, Connecticut

# PHOTOGRAPHIC LOG

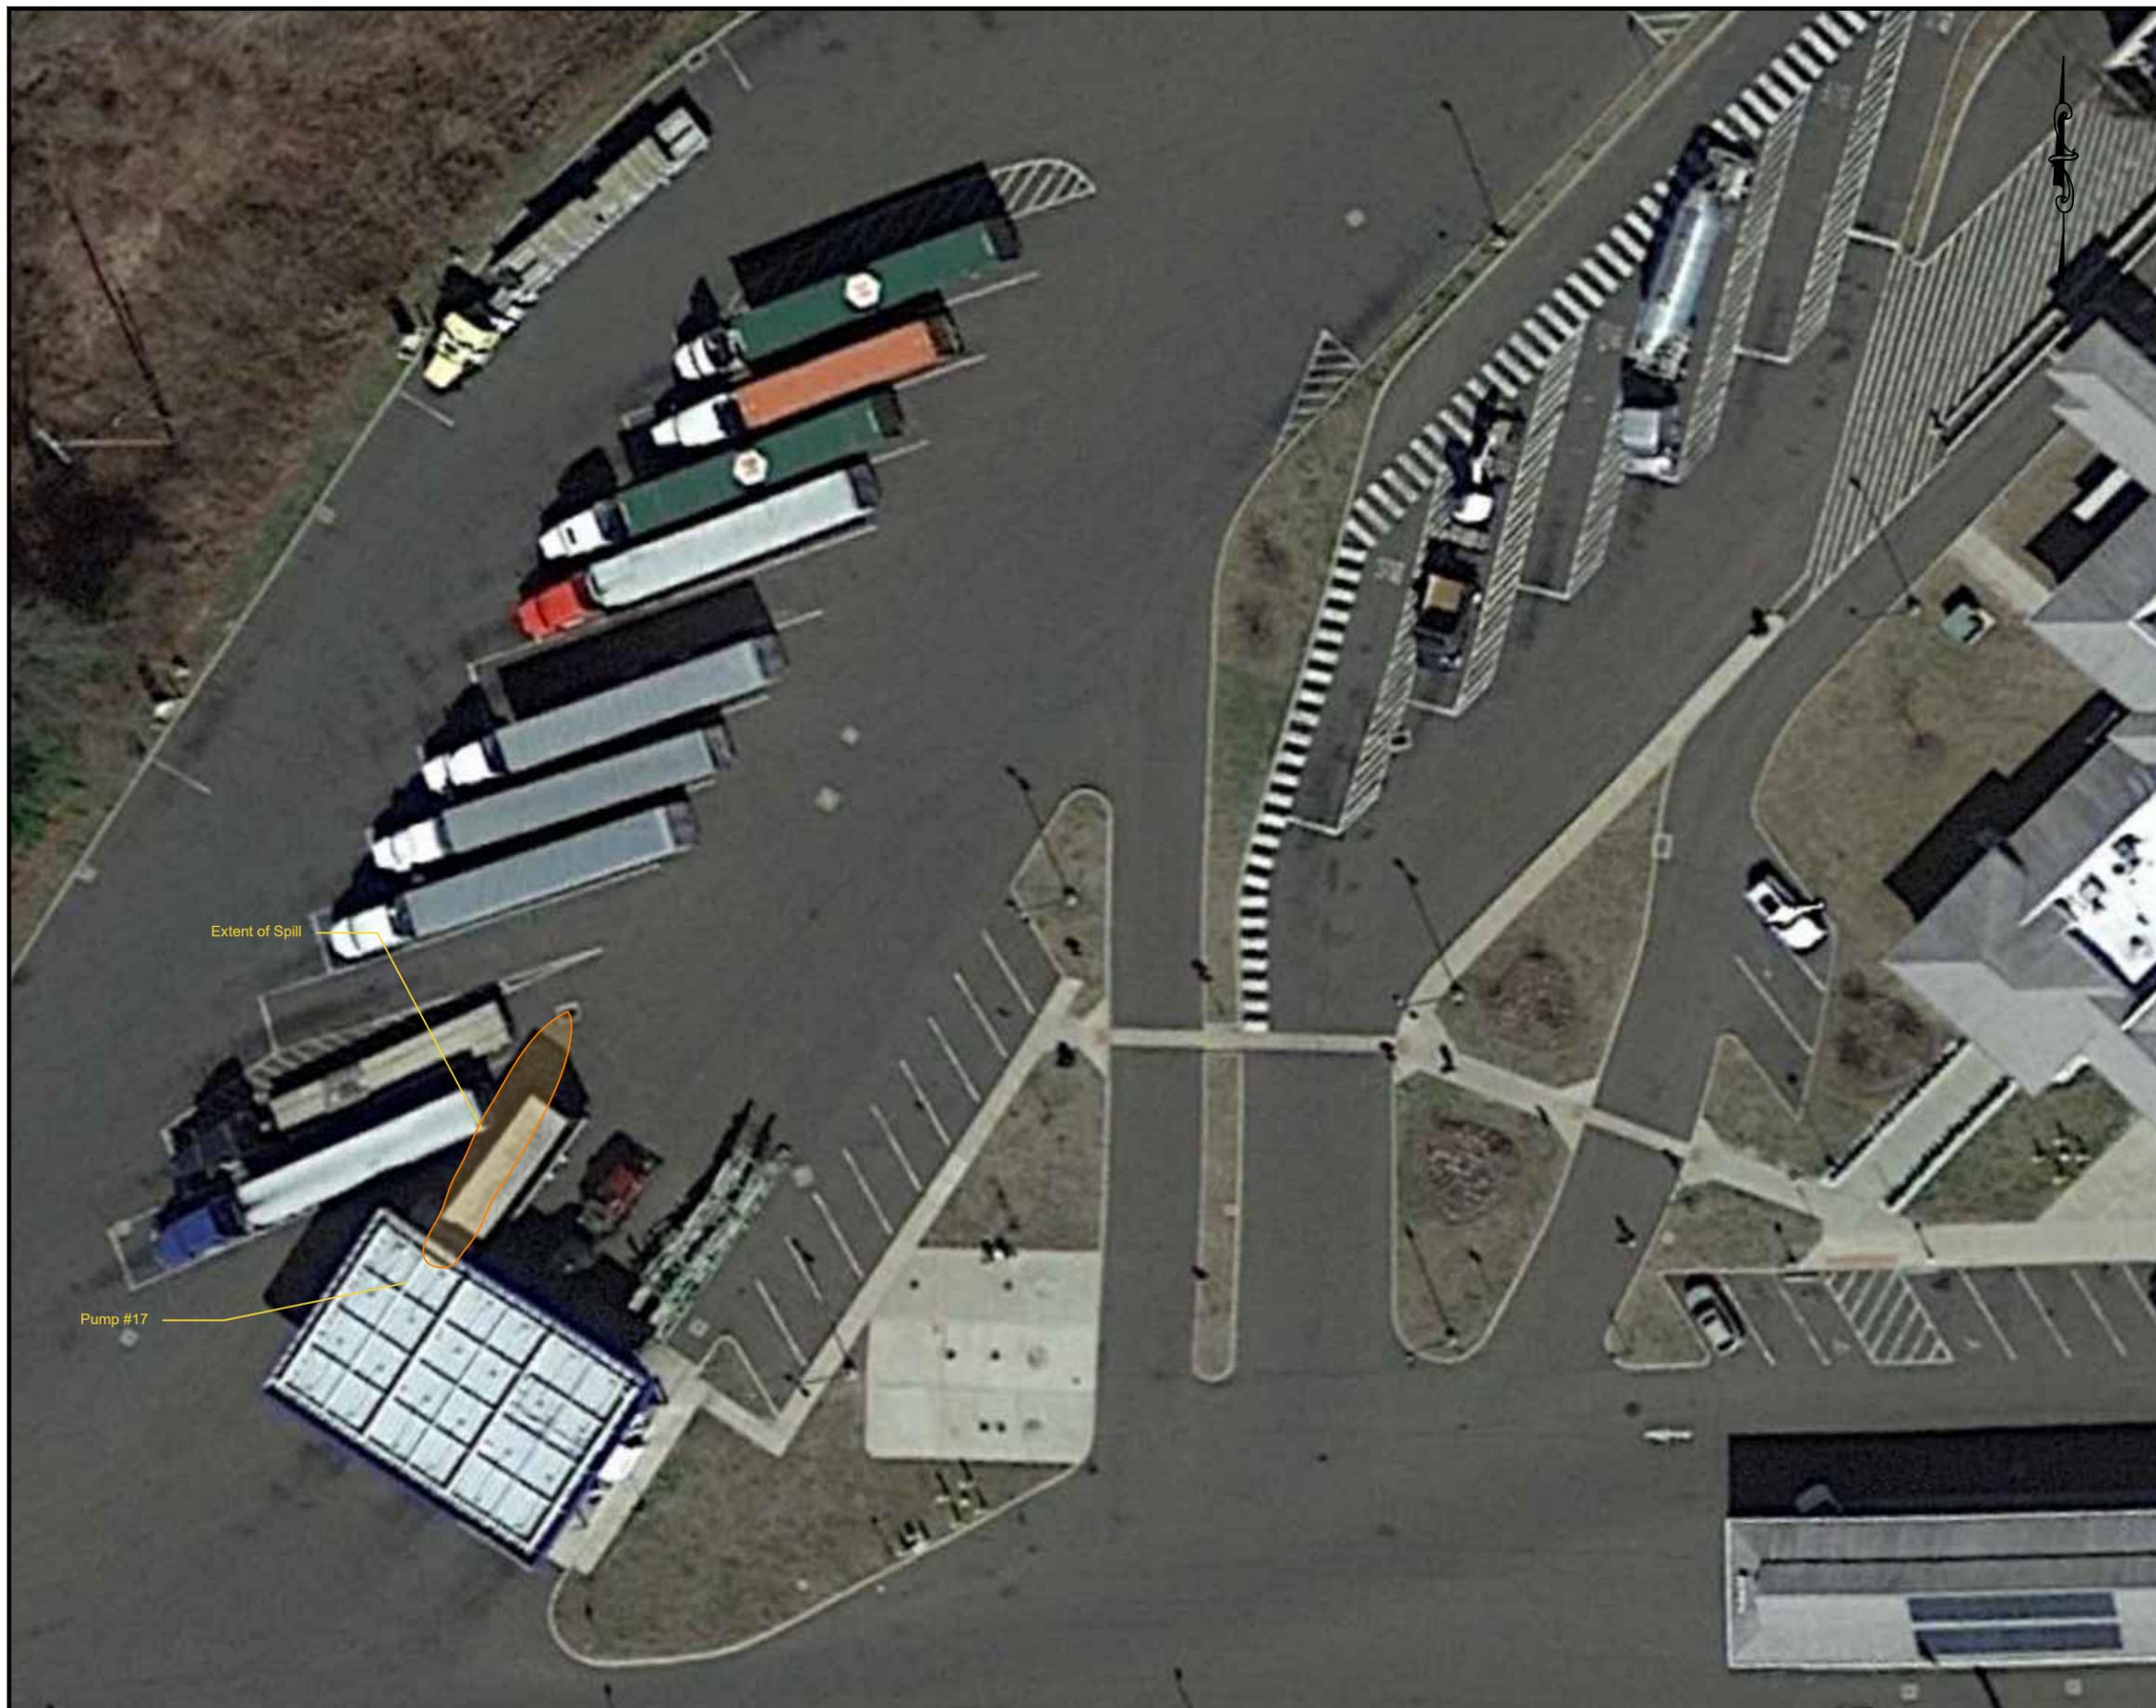
TITLE: **Site Plan**

No. The release traveled southeast on the concrete dispenser pad (was partially contained by concrete pad Positive Limiting Barriers (PLBs)) and across the asphalt paved area. Some of the fuel entered a nearby catch basin, but did not reach the outlet pipe and therefore stayed within the catch basin.

Extent of Spill

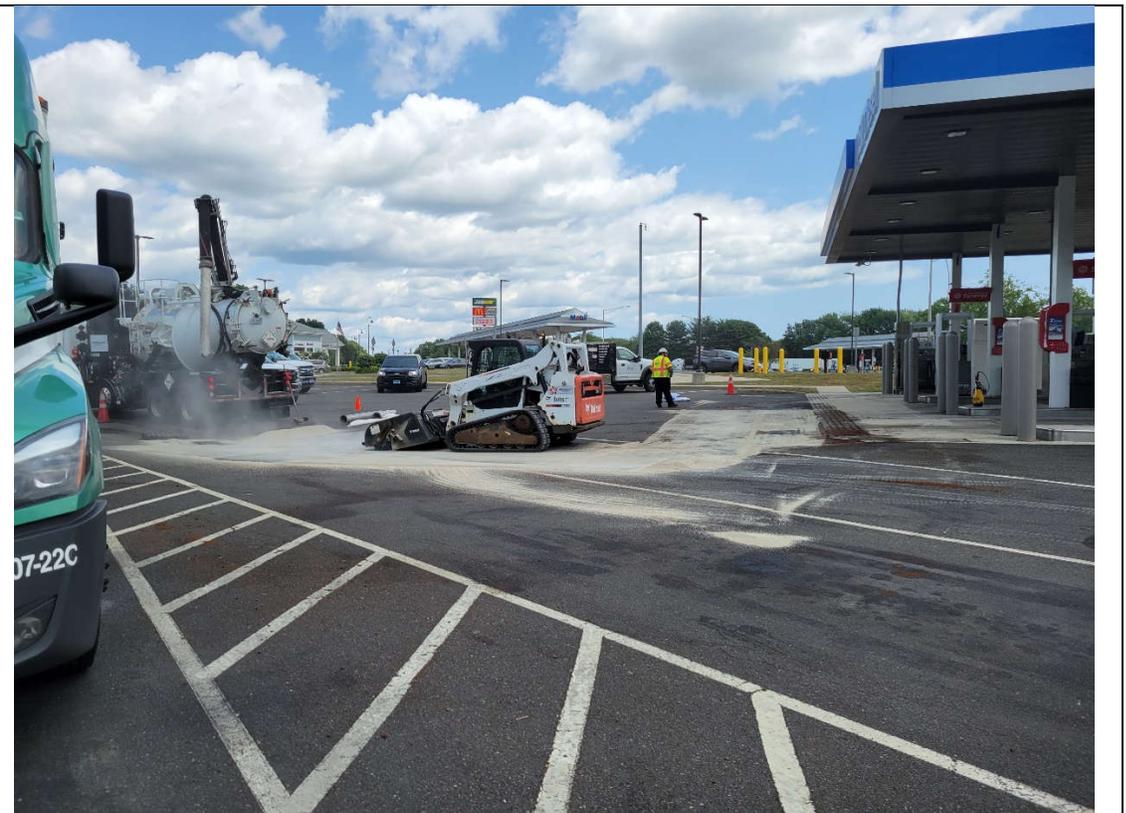
Based on a video recording, the incident occurred as a result of a customer leaving the pump unattended while fueling at dispenser #17.

Approximately 15 gallons of fuel was released from a diesel dispenser to the concrete dispenser pad in the area of dispenser #17.

**Photograph #1**  
**Description:**  
*View of diesel spill from pump #17 to catch basin*

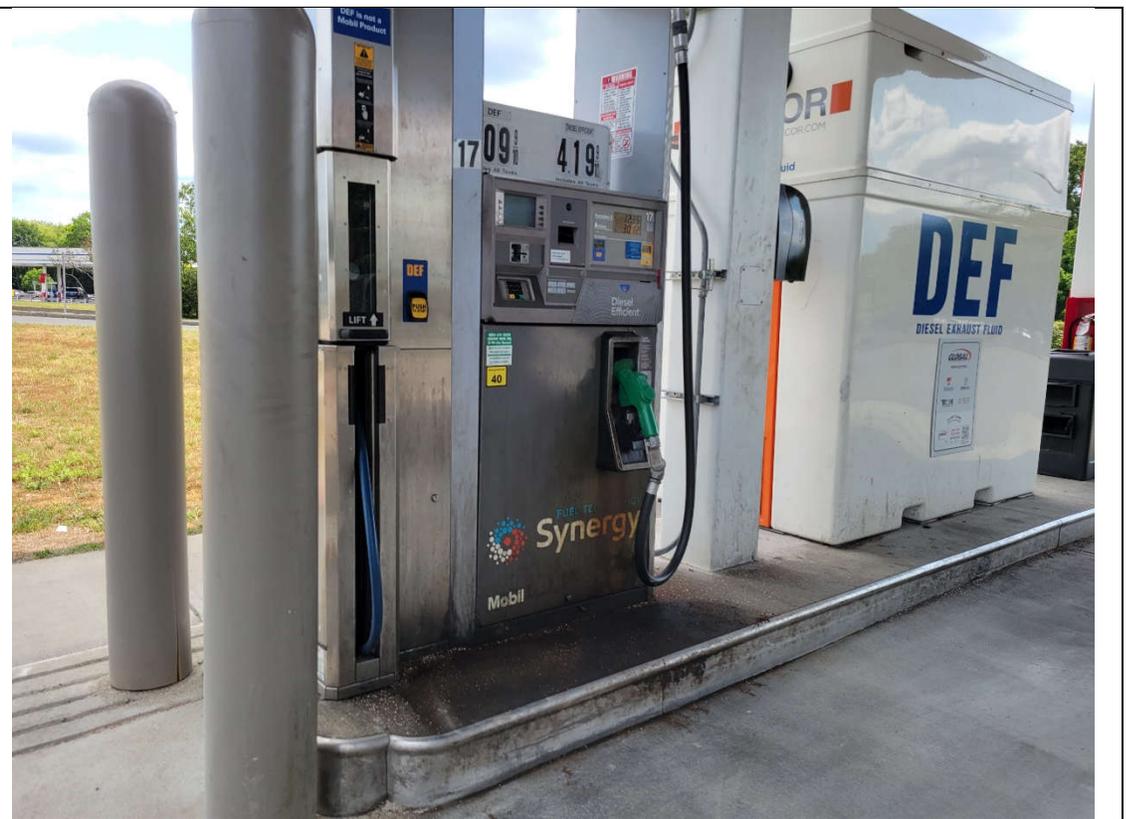
**Photograph #2**  
**Description:**  
*View of pump #17*

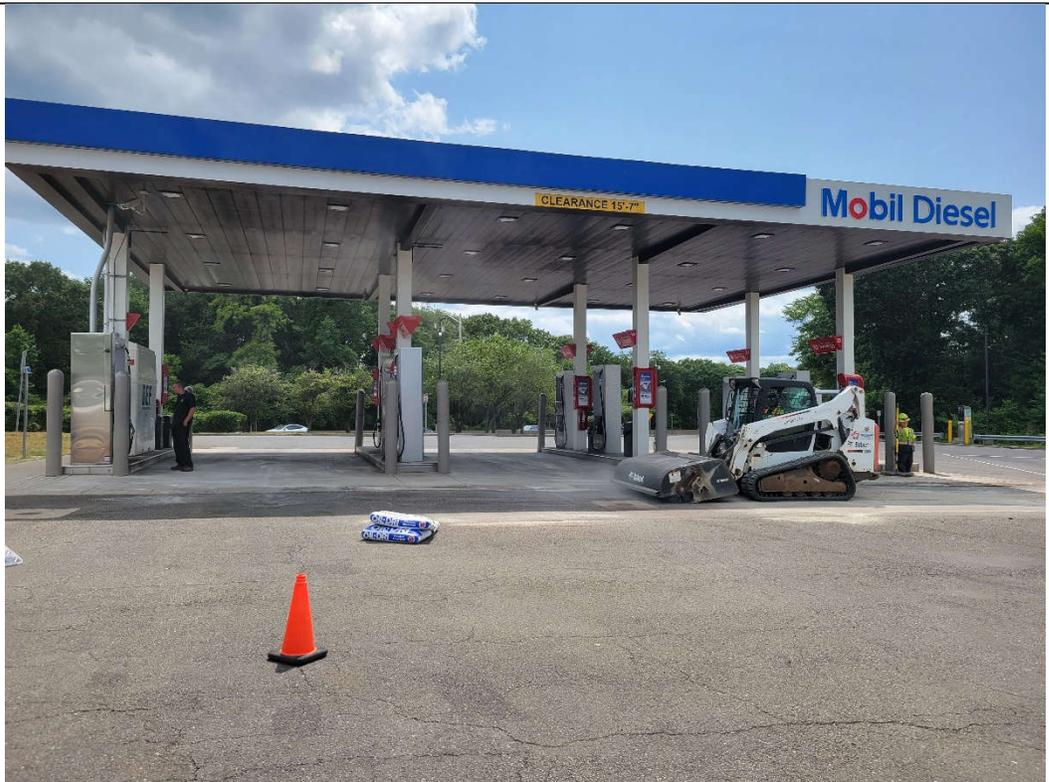
**Photograph #3**  
**Description:**  
*Spill cleanup activities*

At approximately 1:22 PM, US Ecology arrived on Site to investigate and respond to the release. They applied thirty 32-quart bags of granular absorbent material to clean up the spill on the impervious surfaces. The spent absorbent materials were then swept and vacuumed into a vac truck. US Ecology also vacuumed 50 gallons of water and diesel from the catch basin into the vac truck, and placed one absorbent sock into the catch basin. The absorbent sock was left in the catchbasin to absorb any residual diesel remaining following clean-up activities.

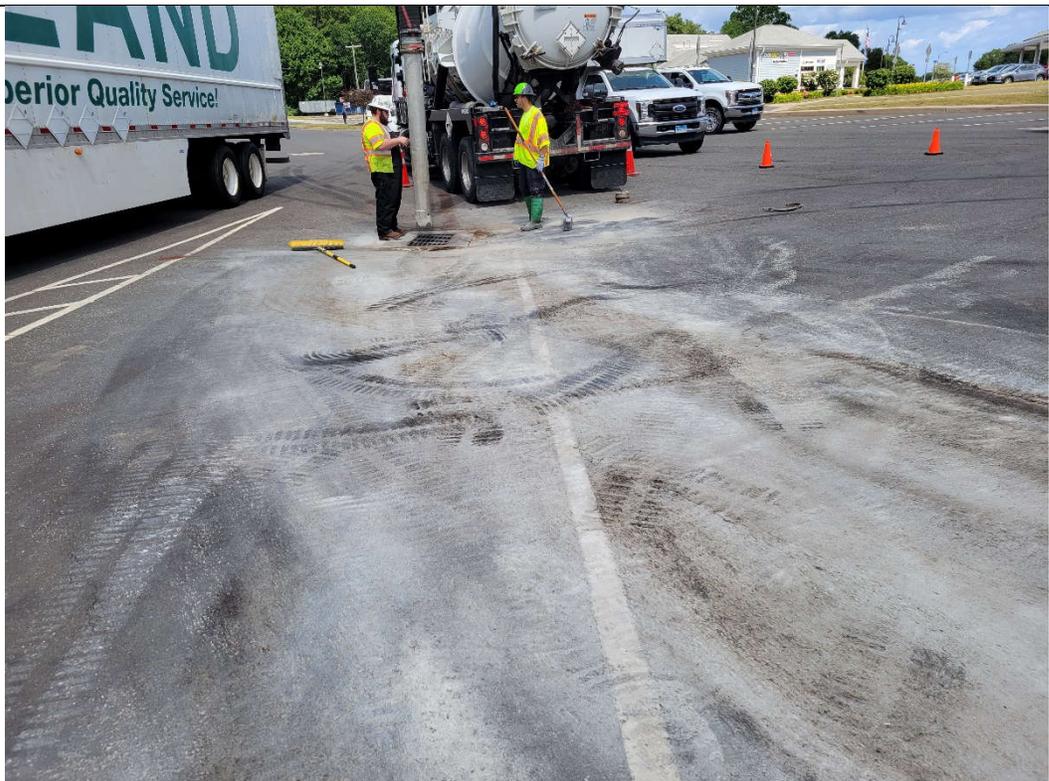
**Photograph #4**  
**Description:**  
*Spill cleanup activities*

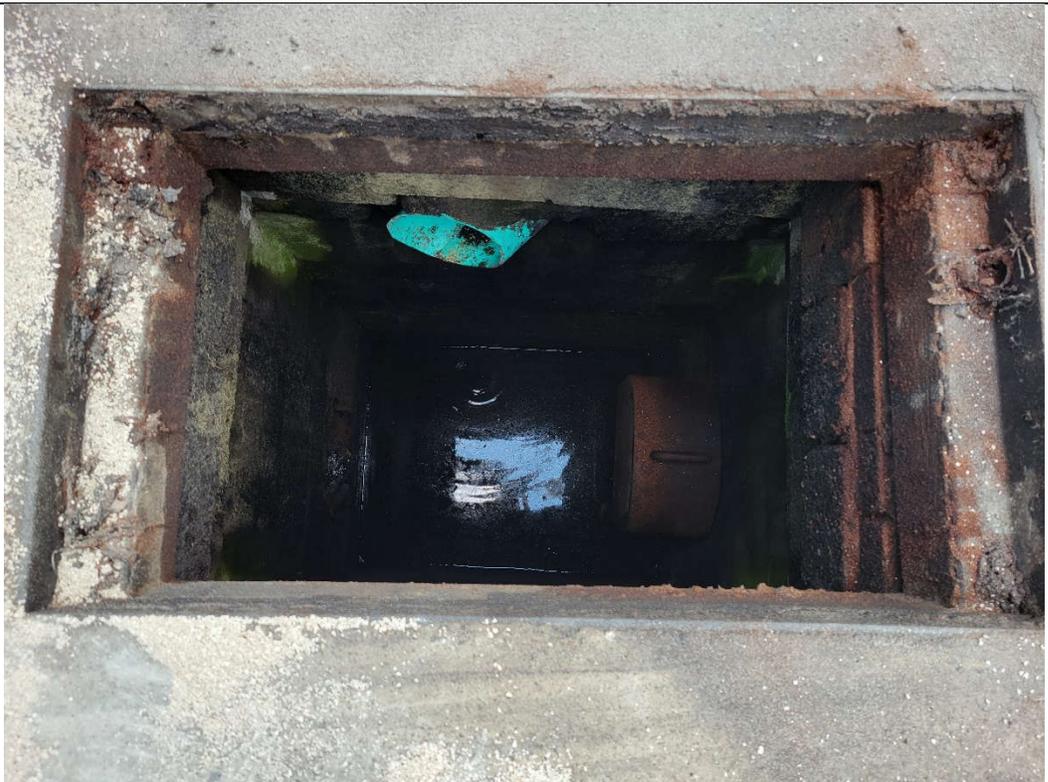
**Photograph #5**  
**Description:**  
*Catch basin with oil sheen in water*

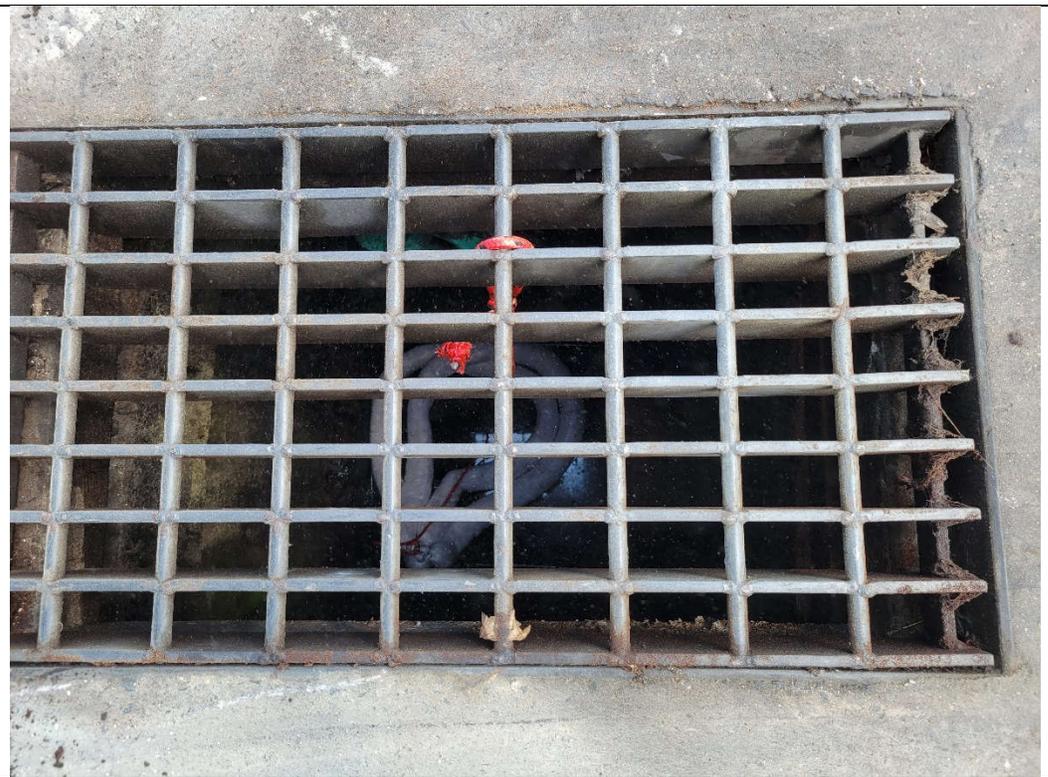
**Photograph #6**  
**Description:**  
*Absorbent sock placed in catch basin*
