Subject: Tank Removal, February 14th & 16th, 2023
Residence @ 7 Parsonage Road in Greenwich, CT
Greenwich Plumbing/HVAC Permit # 23-0237

On February 16, 2023, Enviroshield personnel completed the removal of one 275-gallon underground steel fuel oil tank that had serviced the pool heater and a 1,000-gallon fiberglass fuel oil tank that had serviced the residence located at the subject property. The tank removal process has been documented in three site photographs included with this report.

Appendix A – Site Photographs

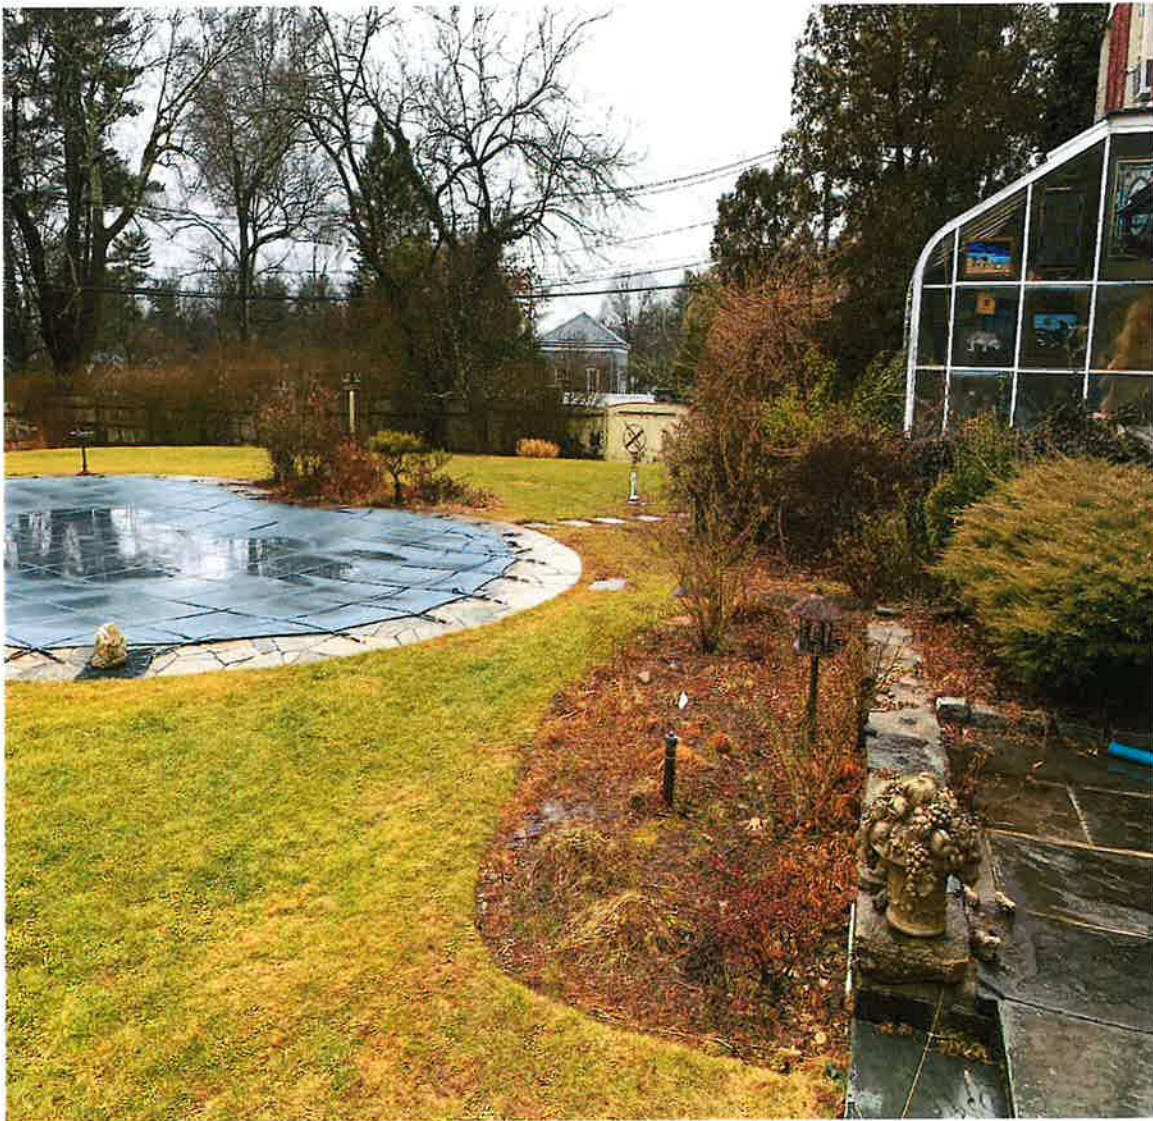
Page 1 of 6

Image of location of the 1,000-gallon FG UST prior to removal:

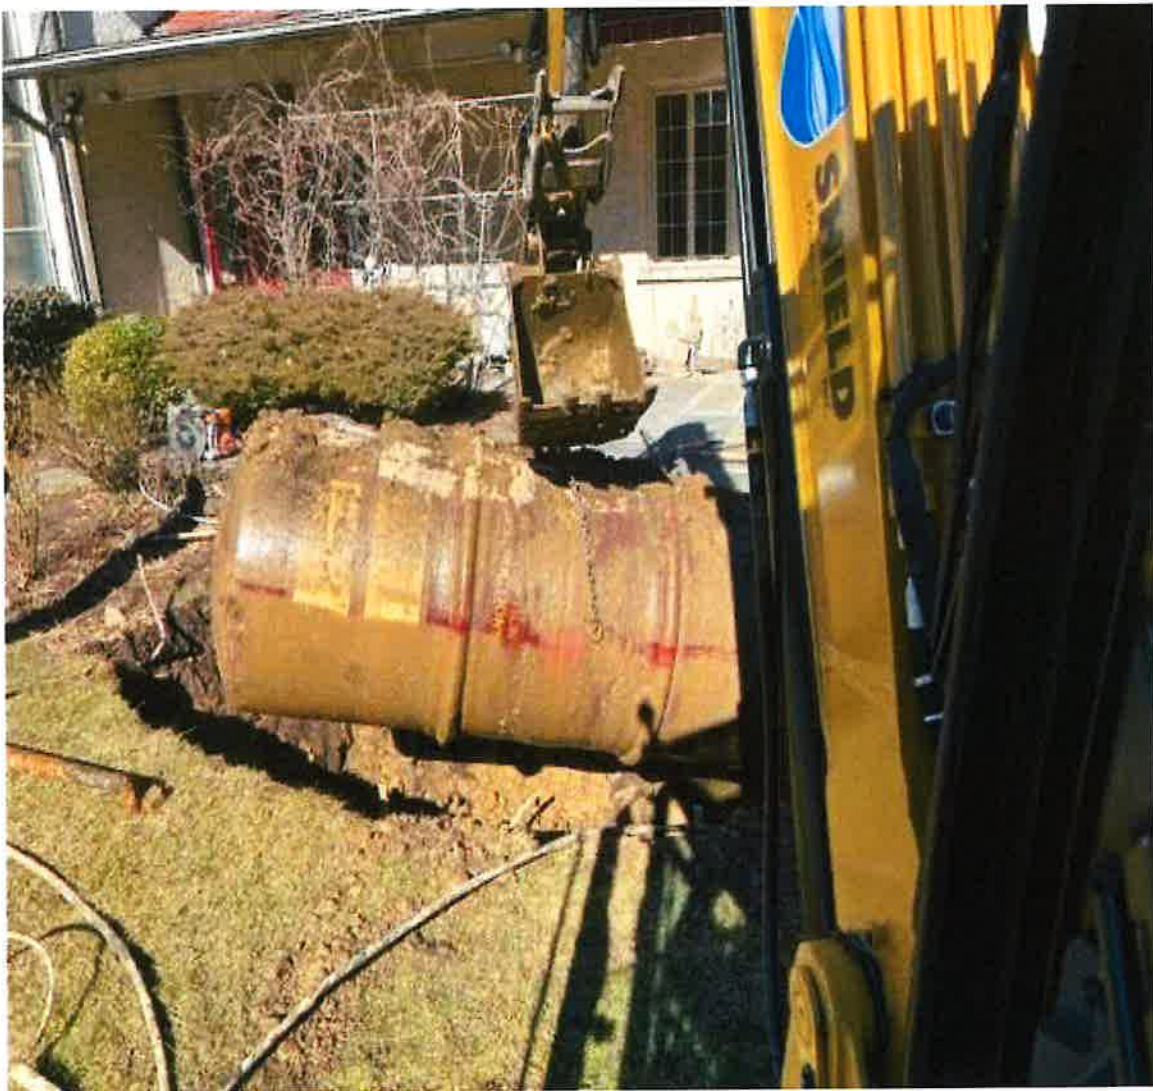
Page 2 of 6

The top of the tanks were exposed using an excavator and enough soil was removed from the excavations to pull the tanks from the ground. The tanks were thoroughly inspected for rust, cracks, holes, or other physical characteristics, which could have been the cause of a fuel release. No evidence of a fuel release was observed from the 1,000-gallon fiberglass tank; evidence of a fuel release was observed under the 275-gallon steel tank.

Image of the 1,000-gallon FG tank being removed:

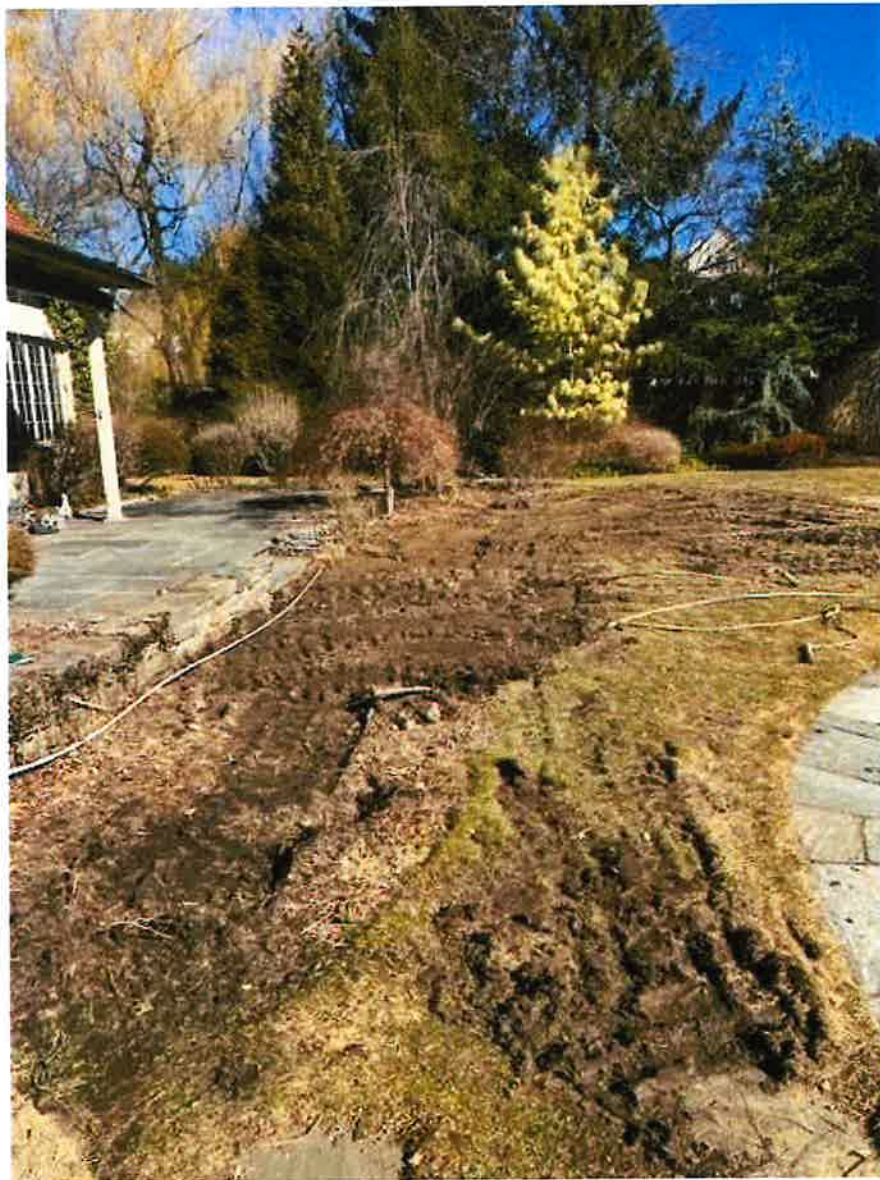
Page 3 of 6

Image after removal of 1,000-gallon FG UST and backfill of the area:

The steel tank was transported, cleaned, and disposed at P.C. Metals, Inc., 270 Central Avenue, Bridgeport, Connecticut; the fiberglass tank was transported, cleaned, crushed, and disposed as common debris, both in a manner consistent with industry standards and in compliance with all Local, State and Federal Codes and Regulations. The tank graves were backfilled.

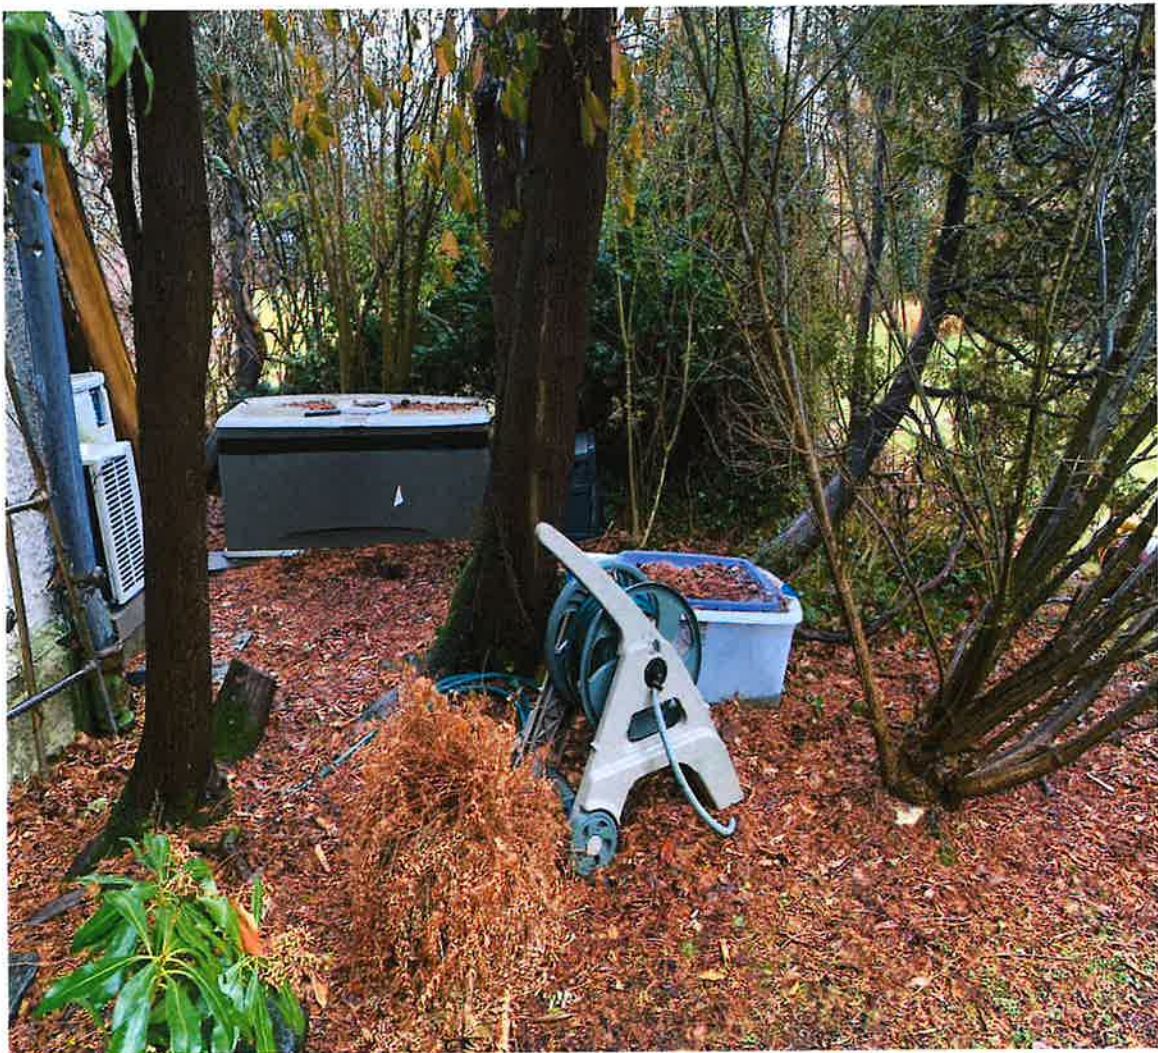
Page 4 of 6

Image of the 275-gallon steel pool heater tank prior to removal (the fill pipe is below the white flag):

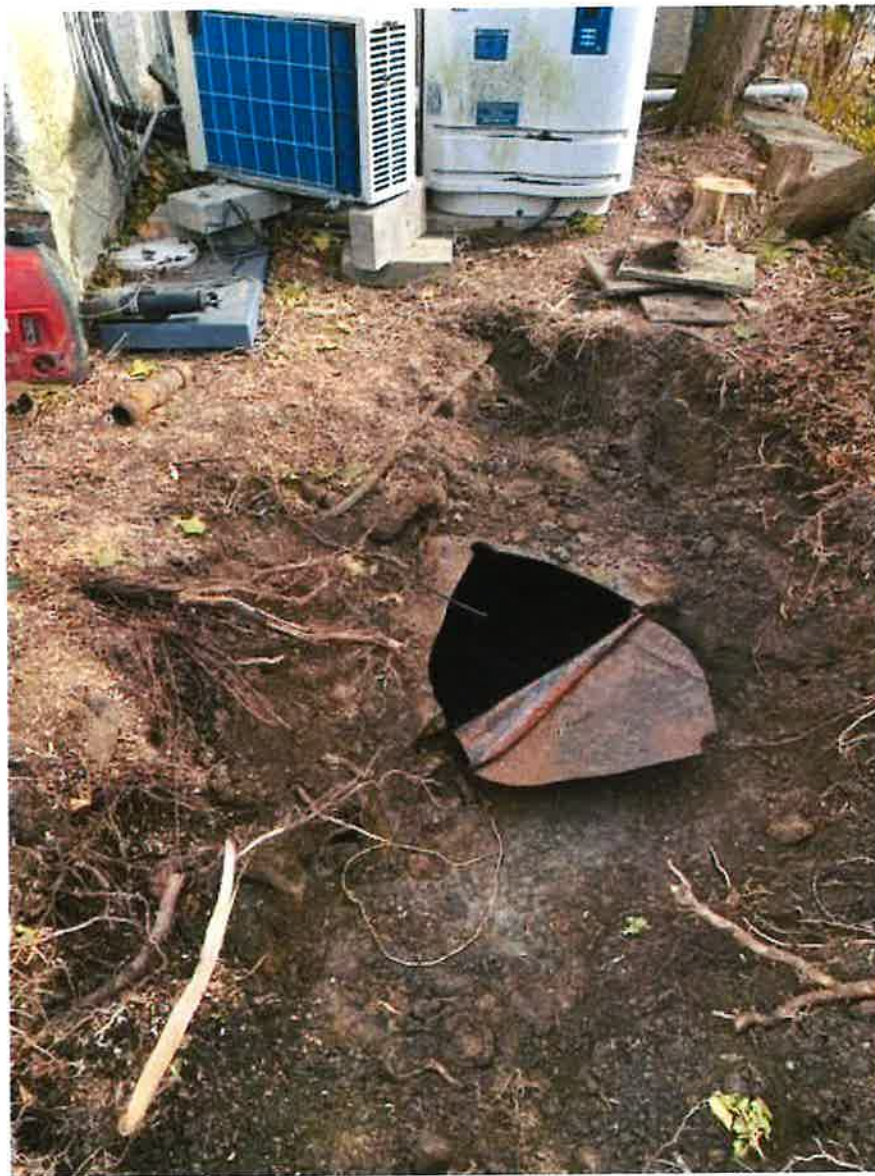
Page 5 of 6

Based on visual observations, PID field screening and laboratory analysis, Enviroshield found no indication of the tank system failure of the 1,000-gallon tank system. Based on visual observations, PID field screening and laboratory analysis, we did confirm failure of the 275-gallon pool tank. The CT-DEEP was notified as required by law and Case number 2023-00427 was assigned.

Image of the 275-gallon steel tank excavated, but and cleaned prior to removal:
