# Clean, Preserve...Protect Environmental Specialists

**Subject:** Underground Tank Investigation and  
Soil Remediation

**Location:** Residential Property  
173 Parsonage Road  
Greenwich, Connecticut 06830

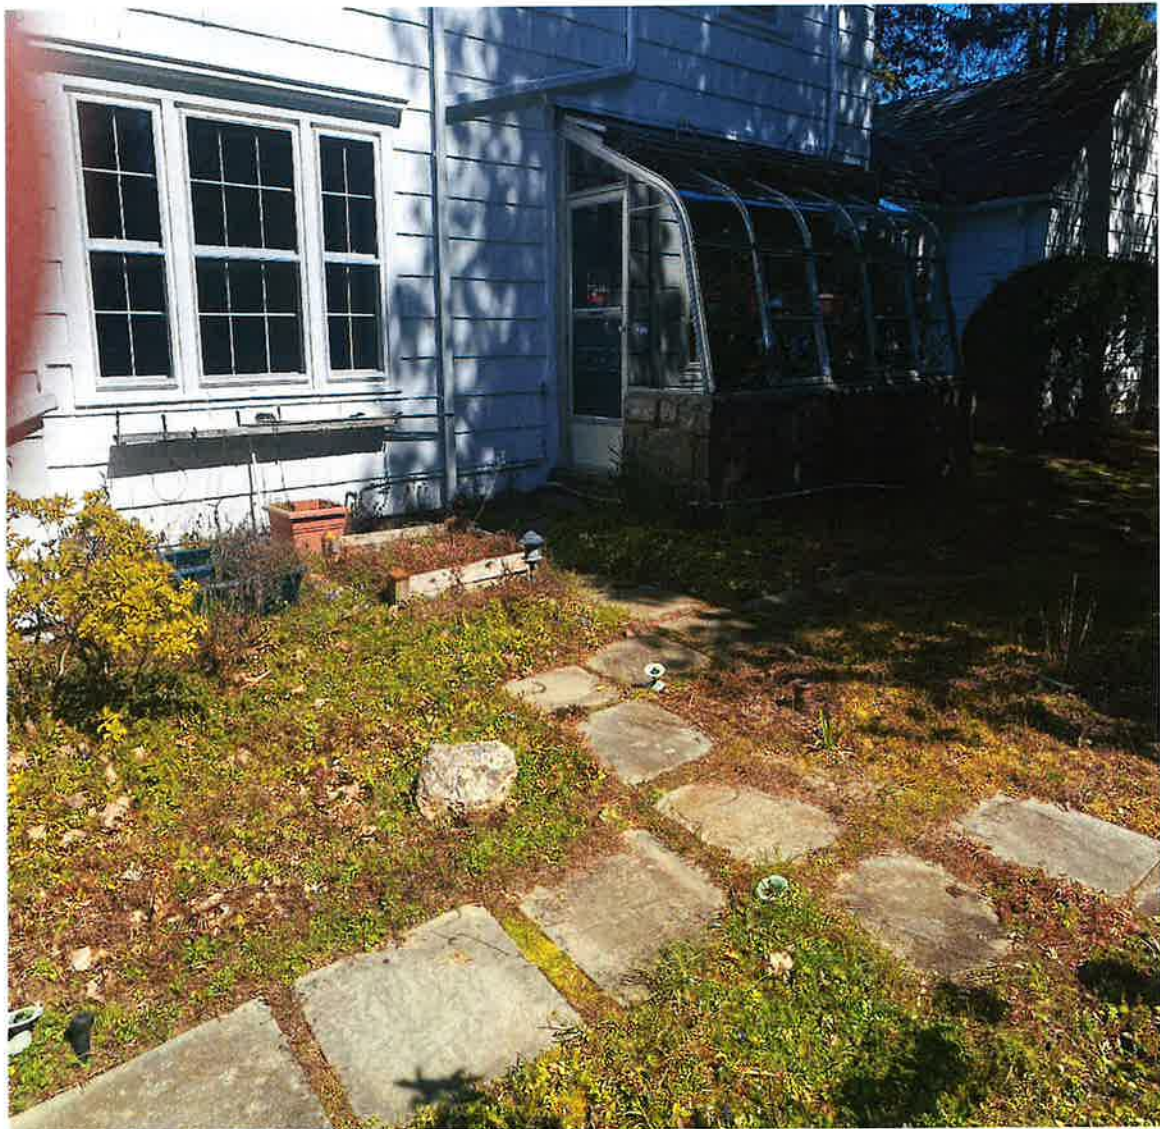
Page 1 of 3

Image of the area under which (is) buried a 1,000-gallon underground storage tank (UST):

Enviroshield personnel excavated and removed one (1) 1000-gallon underground fuel oil storage tank from the subject site. The former location of the tank is indicated in Site Photograph 1 and 2 of 3, contained in Appendix A with this report. A total of 620 gallons of liquid (content and rinse water) was pumped from the tank. The liquid was transported by Enviroshield and disposed of at Tradebe Treatment & Recycling of Bridgeport LLC, a licensed waste recycling company in Bridgeport, Connecticut. A copy of the liquid waste transport Bill of Lading is contained in Appendix B with this report.

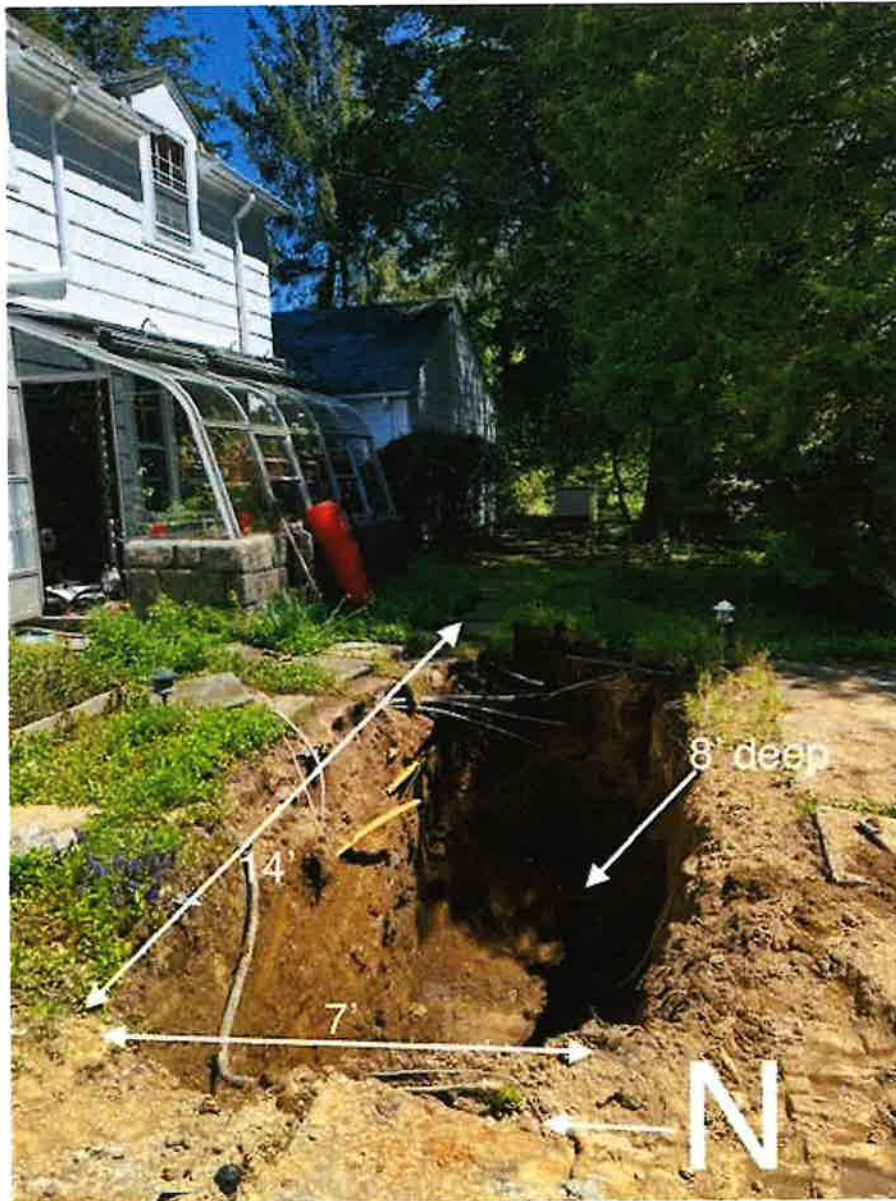
Page 3 of 3

Image of completed excavation / abatement of oil impacted soil:

Twenty-six point four (26.40) tons of fuel oil contaminated soil was transported to Clean Earth of Carteret. Clean Earth is a licensed soil disposal/recycling facility located in Carteret, New Jersey. A copy of the waste transport manifest, and weight ticket are included in Appendix B. The final dimensions of the excavation were approximately 14' by 7' to a depth of 8' as indicated in Site Photograph 3 in Appendix A.

Post excavation soil samples were collected from the bottom of the four walls and the center bottom of the excavation for ETPH analysis. The soil samples were submitted to CET; as indicated in the Analytical Report CET # 3050236 contained in Appendix C, all the post excavation samples yielded results below the regulatory criteria as summarized below:

All the oil impacted soil was removed and disposed of off-site. The area was backfilled to surrounding grade.
